**DEPARTMENT OF TRANSPORTATION**

Contract #: 04-0120F4Cty: SF/ALA Rte: 80 PM: 13.2/13.9File #: 1.28**WELDING INSPECTION REPORT****Resident Engineer:**Siegenthaler, Peter**Address:** 333 Burma Road**City:** Oakland, CA 94607**Report No:** WIR-022409**Date Inspected:** 04-Apr-2011**Project Name:** SAS Superstructure**OSM Arrival Time:** 700**Prime Contractor:** American Bridge/Fluor Enterprises, a JV**OSM Departure Time:** 1530**Contractor:** American Bridge/Fluor Enterprises, a JV**Location:** Job Site

## WELDING INSPECTION REPORT

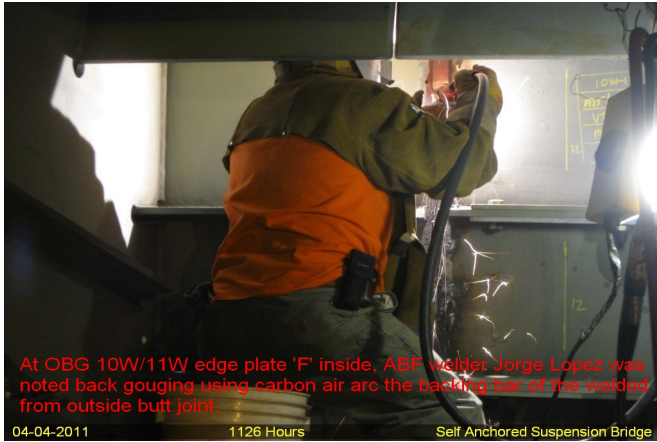
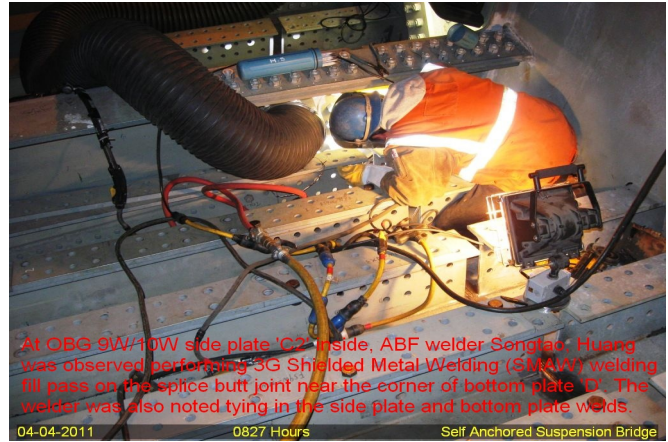
At OBG 9W/10W side plate 'C2' inside, QA randomly observed ABF/JV qualified welder Sungtao, Huang ID # 3794 continuing to perform CJP groove (splice) welding fill pass to cover pass on the splice butt joint at the corner with bottom plate 'D' where the track mounted Bug-o nozzle holder has limited access . The welder was observed perform manual welding in the 3G (vertical) position utilizing a Shielded Metal Arc Welding (SMAW) with 1/8" diameter E7018H4R electrode and implementing Caltrans approved Welding Procedure Specification (WPS) ABF-WPS-D15-1040B. The joint being welded has a single V-groove butt joint with backing bar. During welding, ABF Quality Control (QC) William Sherwood was noted monitoring the welding parameters of the welder. At the end of the shift, cover pass welding at location mentioned above was completed.

At OBG 10E/11E top deck plate 'A3' & 'A5' outside, QA randomly observed ABF/JV qualified welder Wai Kitlai perform CJP repair welding. The welder was noted welding in 1G (flat) position utilizing SMAW with 1/8" diameter E7018H4R electrode implementing new Caltrans approved Welding Procedure Specification (WPS) ABF-WPS-D15-1003 Repair. The new repair procedure includes putting in place a copper backing alongside the typical steel backing bar when the repair excavation is expected to occur at the edge of the steel backing. The first time welding repairs were excavated to a boat shape profile and were tested with Magnetic Particle Testing (MT) prior welding. During welding, ABF QC Jesse Cayabyab was noted monitoring the welder and his welding parameters. QA noted parameter during welding was 130 amperes which appears in compliance to the WPS. The

At OBG 10W/11W edge plate 'B' inside, QA randomly observed ABF/JV qualified welders Fred Kaddu perform plasma arc gouging on the backing bar removal of the welded from the outside splice butt joint. The groove of gouged butt joint was ground smooth and was tested with Magnetic Particle Testing by ABF QC William Sherwood. After the completion and MT acceptance of the backing bar removal, the welder started back welding the butt joint. The welder was observed manually welding in the 3G (vertical) position utilizing a Shielded Metal Arc Welding (SMAW) with 1/8" diameter E7018H4R electrode and implementing Caltrans approved Welding Procedure Specification (WPS) ABF-WPS-D15-1040B. The joint being welded has a single V-groove butt joint with steel backing bar. ABF Quality Control (QC) William Sherwood was noted monitoring the welding parameters of the welder. QA randomly monitored the welding parameters with reading of 138 amperes which appears in conformance to the contract requirements. At the end of the shift, SMAW fill pass welding was still continuing and should remain tomorrow.

During the fit up from the outside on this edge plate, ABF QC William Sherwood informed this QA that there was a misalignment of 4mm from Y=825mm to Y=1015mm on this 28mm thick edge plate. QC also mentioned to QA that this misalignment will be mapped and recorded and an internal QC Incident Report submitted to ABF.
